Refurbishment Survey Report Assessment and Register of Asbestos Containing Materials

Selected areas of Churchill
House, Churchill Way, Cardiff,
CF10 2HH

CBOF Group

Job No J029109

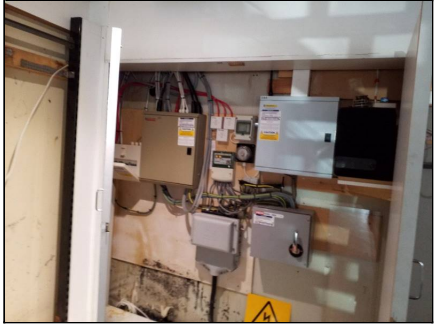
Inspection Number	Location/Description	Comments	Advised Action	Photograph
Inspection 14 Presumed	Ground Floor, Throughout, No access to electrical equipment	Live at the time of survey; no isolation provided by the client	Survey prior to works

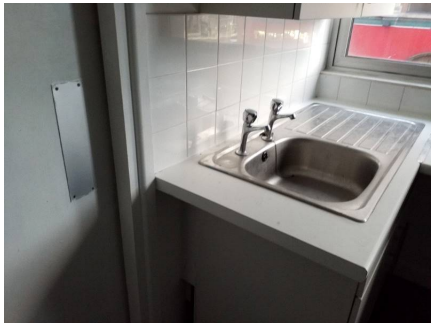
Inspection Number	Location/Position/Description	Product	Comments	Photograph
Inspection 9 CQ000724	Mezzanine, 009 Kitchen, Bitumen acoustic pad to underside of sink	Bitumen	1no. Good Condition Reinforced Composite Material
